1000/700 ALLEN GWYNNE PUMP PROTECTED WITH BELZONA

ID: 787

Industry: Water / Wastewater
Application: CEP-Centrifugal Pumps
Substrate: Cast Iron
Products: Belzona® 1341 (Supermetalgilde)

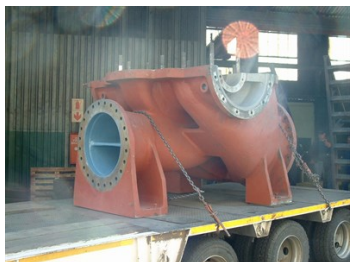
* Pump being delivered to OEM after coating. , * Pump internals , * 9 ton bottom Section , * Pump suction ,

Application was carried out in accordance with Belzona System leaflet CEP-10

40 Kg of Belzona® 1341 were applied to this pump. This water authority has standardized on Belzona® 1341 for all their water pumps.
