Belzona Cold Bonding System for Water Sprinkler Tank

ID: 7905

Industry: Oil & Gas
Application: TCC-Tanks and Chemical Containment Areas
Substrate: Carbon Steel
Products: * 1161 (Super UW Metal),

Customer Location: Indonesia
Application Date: 2018

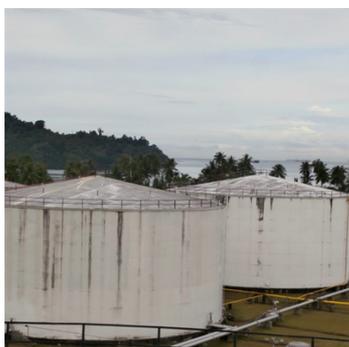
- * 1. Crude Oil Storage Tanks ,
- * 2. Surface preparation by Grinding ,
- * 3. Bonded Bracket 4. Completed Application ,
