# Belzona Cold Bonding System for Water Sprinkler Tank

ID: 7905

Industry: Oil & Gas  
Application: TCC-Tanks and Chemical Containment Areas  
Substrate: Carbon Steel  
Products: \* 1161 (Super UW Metal),

Customer Location: Indonesia  
Application Date: 2018

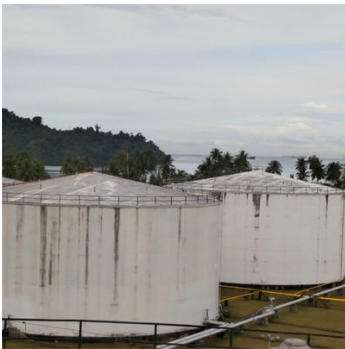
- \* 1. Crude Oil Storage Tanks ,
- \* 2. Surface preparation by Grinding ,
- \* 3. Bonded Bracket 4. Completed Application ,
