BELZONA BONDS FRAMEWORK TO OILRIG DECK

ID: 792

Customer Location: Norwegian Oil Operator
Application Date: January 2004

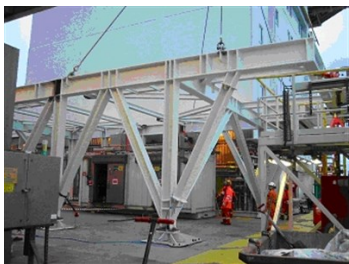
- * Lowering of sub frame into position and alignment. ,
- * Bonding application completed. ,
- * Accommodation Modules in position. ,

The application was carried out in accordance with a modified version of Belzona Know-How System Leaflet GSS-9.

Due to the extended time after alignment/sealing to the bonding phase nitrogen was used to prevent flash rusting in the void to be filled with the Belzona® 5811. To combat the very cold conditions in the North Sea, January (0°C) heat blankets were used to allow

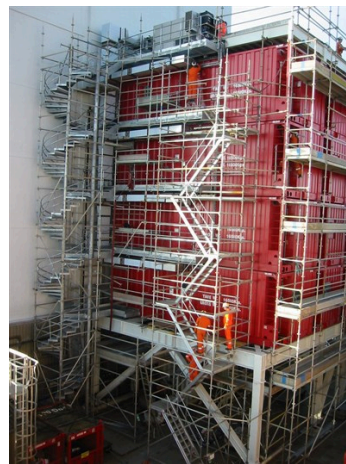
Module in place for 9 years weighing around 145 tonnes.
