BELZONA BONDS FRAMEWORK TO OILRIG DECK

ID: 792

Customer Location: Norwegian Oil Operator
Application Date: January 2004

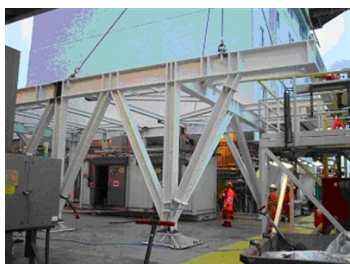
- * Lowering of sub frame into position and alignment. ,
- * Bonding application completed. ,
- * Accommodation Modules in position. ,

Due to the extended time after alignment/sealing to the bonding phase nitrogen was used to prevent flash rusting in the void to be filled with the Belzona® 5811. To combat the very cold conditions in the North Sea, January (0°C) heat blankets were used to allow

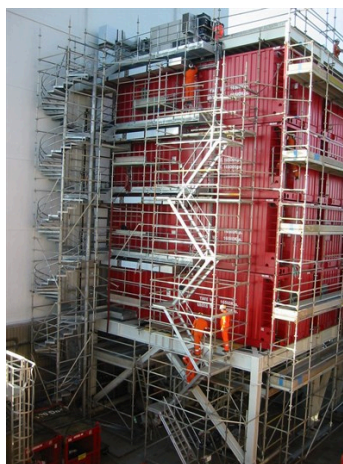
Module in place for 9 years weighing around 145 tonnes.
