Brewery Floor Protected with Long-Lasting Belzona Coating

Industry: Food & Drink
Application: FPA-Floor Problem Areas
Substrate: Concrete
Products: * Belzona 5231 (SG Laminate) ,

Customer Location: Brewery - Cape Town, South Africa
Application Date: 2018

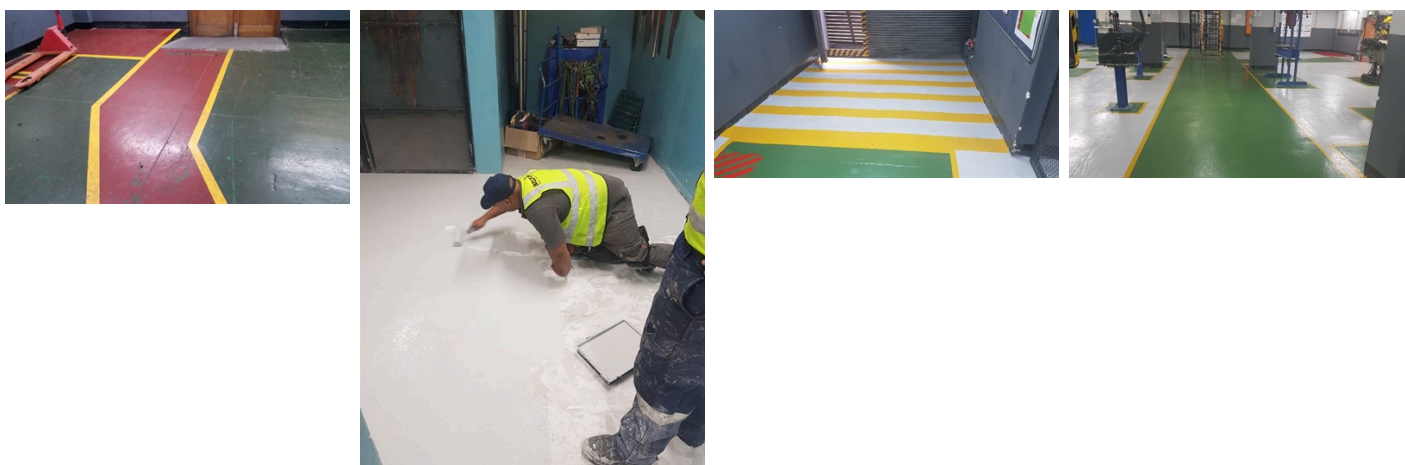
Photograph Descriptions

- * 1. Damaged floor coating that required constant re-application ,
- * 2. Application of Belzona 5231 ,
- * 3. Vibrant colours help to differentiate sections ,
- * 4. Further applications completed as a result of the original ,

The floor in a major brewery's workshop was needing continual maintenance. The floor paint they were using did not last long and had required constant re-application over the last 15 years.

This application was carried out in accordance with Belzona Know-How System Leaflet FPA-8 Surface preparation was completed over a 4-day period, followed by 3 days for the application of 60 units of the two-coat system. This resulted in a durable flooring system, which will stay in place for years to come.
