Belzona Provides Erosion Protection on Exhaust Fan

ID: 7929

Industry: *Mining & Quarrying*
Application: *FBC-Fans, Blowers and Compressors*

Substrate: *Carbon manganese steel S355J2G3*
Products: ** Belzona 1812 (Ceramic Carbide FP) ,*
** Belzona 1321 (Ceramic S-Metal) ,*

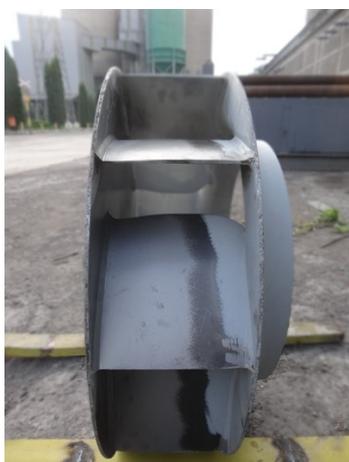
The dry air (70C) carrying Al, Si, MgO, CaO dust erodes the vanes of the fan blades, removing 2.5-3 mm fo thickness from the metal.

- * 1. The eroded fan ,
- * 2. The fan after surface preparation ,
- * 3. The leading faces of the fan blades rebuilt with Belzona 1812 ,
- * 4. The leading faces of the fan blades coated with Belzona 1321 ,
