Belzona alters yacht window frames with ease

ID: 7949

Customer Location: Mallorca
Application Date: June 2018

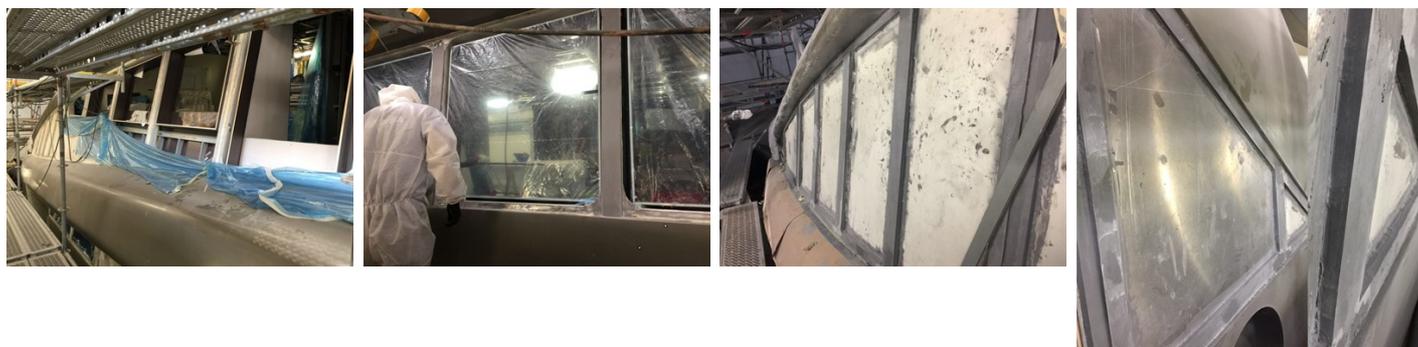
Photograph Descriptions

Due to a last minute design change affecting the thickness of the installed glass, the window frames had to be modified. As the structure had already been built, it was not possible to alter the structural design, and therefore an after market alteration had to be made so that the window frames could accommodate the lower thickness windows.

- * 1. General view of window frames ,
- * 2. Surface being prepared for application ,
- * 3. Belzona applied with formers in place ,
- * 4. Completed application ,

The application was carried out in accordance with a modified version of Belzona System Leaflet GSS-9. Belzona 1121 was used to build up the thickness of the window frames by 1 - 1.5 cm. A forming technique was used to ensure precise tolerances. Belzona 9411 (Release Agent) was applied to the formers so that they could be easily removed after the Belzona 1121 had cured.

Belzona 1121 was selected due to its high build capability, allowing the required thickness to be added to the window frames in a single application. The Belzona material is 100% solids, meaning that it will not distort or shrink whilst curing. This is essential to ensure the correct tolerances can be met. Welding was considered, but rejected as it was deemed the heat stresses could damage

and distort the structural steel. Competitor products did not have the slump resistance to achieve the required thickness at one time, meaning the application would have been much more time consuming.
