# BELZONA APPLIES ANTI-SLIP SYSTEM TO WOODEN MEZZANINE FLOOR

ID: 7963

Customer Location: Distribution Center, Worksop, UK  
Application Date: 2019

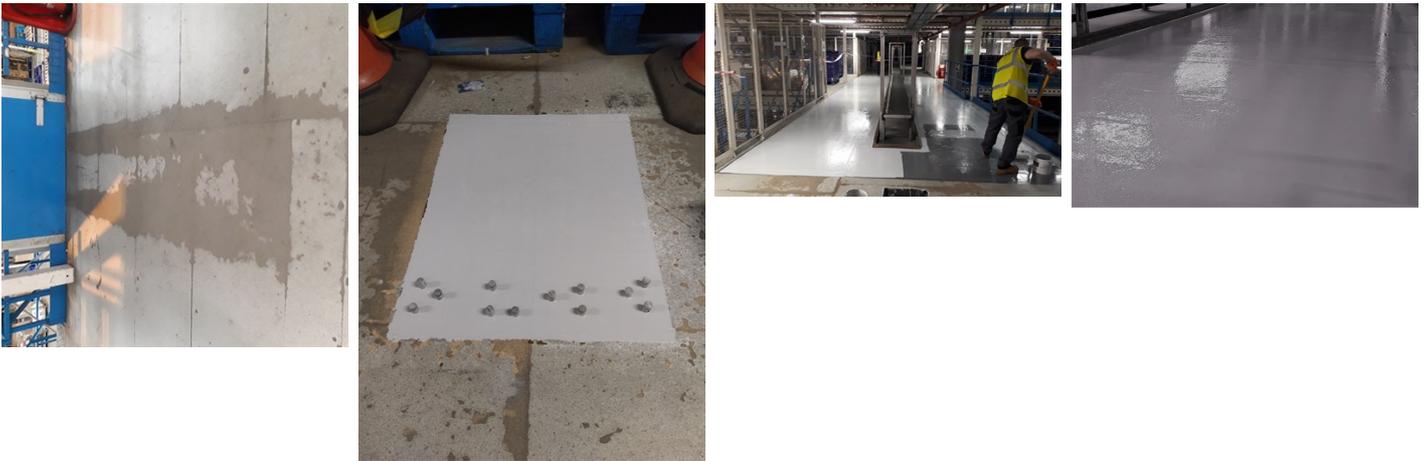
A resin-compacted chipboard floor was the substrate which needed repair. 200Kg tote trolleys were trafficked across this, wearing away the original coating and substrate of the mezzanine floor. The client tried 4 other coatings companies before trialing with Belzona.

- \* 1. Small trial area ,
- \* 2. Dolly pull-offs in place ,
- \* 3. Applying 2nd Coat ,
- \* 4. Trial completed ,

5231 was applied to a small patch, along with pull-off dollies as a small trial area. These showed adhesion approaching 850 psi. From this result, a larger trial was organised. Preparation was completed using large floor sanders and vacuums, followed by the application of the Belzona 5231 in accordance with Belzona system leaflet FPA-8.

All other trials failed and the only alternative seemed to replace the floor. The cost was huge as the mezzanine floor carried services under which also would have had to be moved and managed during the replacement. A coating was the only viable choice. Belzona 5231 was the only coating to perform.

The trial has been in place since the beginning of 2019, and has proven a suitable solution, outperforming the expected standards.
