# BELZONA COATS YACHT'S WATER JET SYSTEM

Industry: *Marine*  
Application: *SOS-Ships and Offshore Structures*

Customer Location: *Tuscany, Italy*  
Application Date: *March 2010*

Substrate: *Aluminium*  
Products: *\* Belzona 1341 (Supermetalgilde) ,*

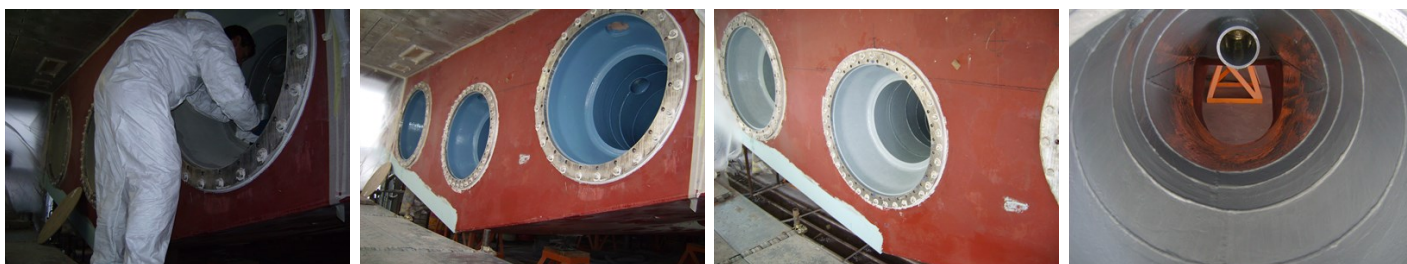
- \* 1. Water jets during the cleaning phase ,
- \* 2. View after the first coat of Belzona 1341 ,
- \* 3. View after the second coat of Belzona 1341 ,
- \* 4. Finished application ,

Application was carried out in accordance with Belzona Know-How system leaflet SOS-02. The substrate was blasted to SA 2.5 cleanliness and cleaned with acetone. 2 coats of Belzona 1341 (Supermetalgilde) were then hand applied to coat the system.
