# BELZONA SEALS HOTEL POOL DECK

**Industry:** Buildings & Structures  
**Application:** FPA-Floor Problem Areas  
**Substrate:** Concrete  
**Products:** \* Belzona® 4111 (Magma Quartz),  
\* Belzona® 3121 (MR7),

**Customer Location:** Hotel, Pensacola Florida  
**Application Date:** September, 2001

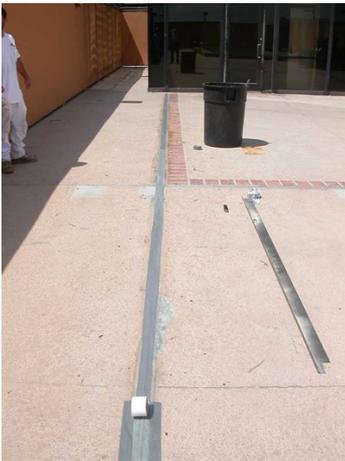
- \* Stress cuts in concrete ,
- \* Belzona® 4111 with drain in place ,
- \* Finished drain area ,
- \* Finished pool deck ,

Belzona® 4111 applied to deck after careful preparation including levelling with a grinder. The drain covers were prepared and set in place with Belzona® 4111. Belzona® 3121 was used to seal stress cuts in the pad after they were cleaned, dried and prepared with a concrete grinder.
