# Belzona Gives New Life to Fan Blades

ID: 7982

Industry: *Chemical & Petrochemical*  
Application: *FBC-Fans, Blowers and Compressors*

Customer Location: *Rayong, Thailand*  
Application Date: *2018*

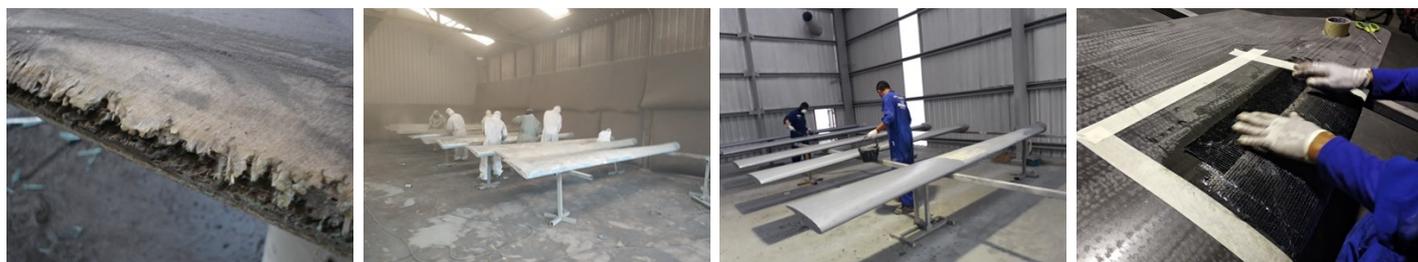
## Photograph Descriptions

*Deposit, erosion and mechanical damage of FRP fan blades for cooling tower were observed during turnaround period*

\* Lead Edge Damage Surface Preparation using Power tools application of Belzona 5111 Application of SWII ,

More than 1,400 pieces of fan blades were coated by Pan Mechanic Engineering with the Belzona 5911 and Belzona 5111 system. And recently we have also adapted Belzona SuperWrap II for repairing fan blades cracks because FRP fan blades need repair systems which have high strength and lightweight properties.
