# Belzona Solution for Corroded Riser Casing

Industry: *Chemical & Petrochemical*  
Application: *TCC-Tanks and Chemical Containment Areas*

Customer Location: *Gulf of Thailand*  
Application Date: *2018*

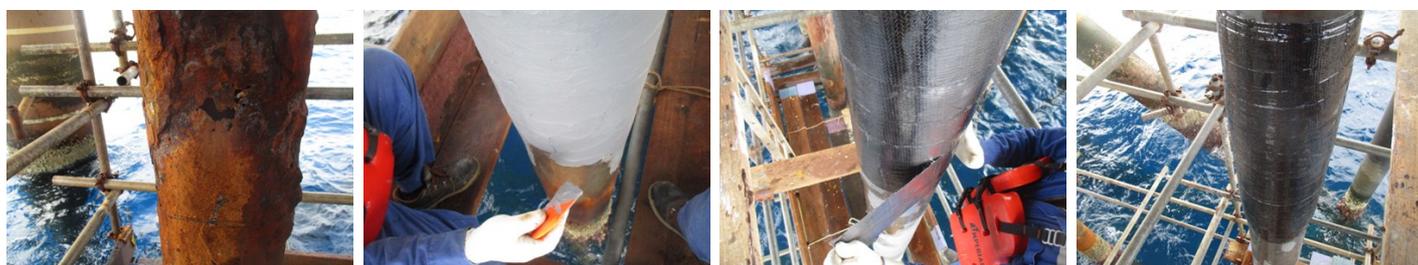
## Photograph Descriptions

*Leaked and severe corroded surfaces were observed on splash zone of riser casing.*

- \* 1. Corroded Riser Casing ,
- \* 2. Rebuilding with Belzona 1111 ,
- \* 3. Superwrap 2 Application ,
- \* 4. Completed Application ,

Repair parameters, repair thickness, number of wrap and wrapping length have been calculated from operating condition of the pipe which are provided by customer. Surface has been prepared with garnet grit to achieved SA 2 1/2 level of cleanliness and roughness more than 75 microns. Leaked or through wall defects were stopped by Belzona 9611 then rebuilt corroded surfaces with Belzona 1111 then SuperWrap II repair system was applied by using Belzona 1982 SuperWrap II Resin with Belzona 9381 reinforcing fiber.
