Belzona repairs a raw mill in a cement industry

ID: 7986

Industry: *Mining & Quarrying*
Application: *SHM-Solids Handling Machinery*

Substrate: *Mild Steel*
Products: ** Belzona 1111 (Super Metal) ,*

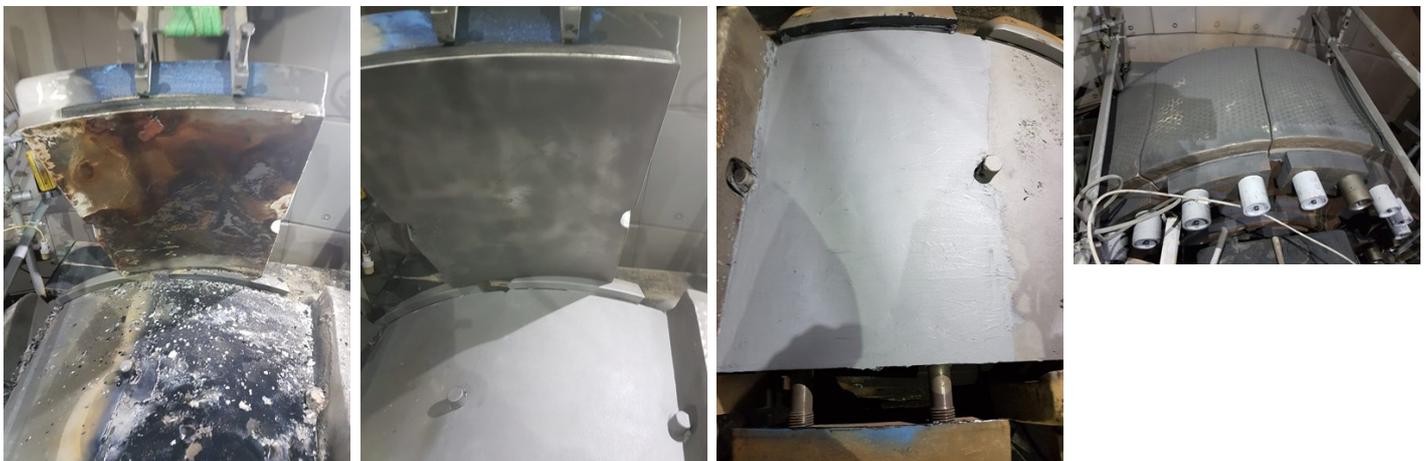
Photograph Descriptions

Problem

- * 1- Before application ,
- * 2- After surface preparation ,
- * 3- After application of Belzona 1111 ,
- * 4- Final application ,

The application was done in accordance with Belzona System Leaflet SHM-8. Two wear plates were removed from the roller at a time and the area on the roller was grit blasted. The back of the new wear plate was also grit blasted and Belzona 1111 was applied to the roller in a layer of approximately 2cm thick in the position corresponding to one wear plate. The wear plate was then fitted onto the wet Belzona 1111 to create a perfect seat. The process was repeated until 12 wear plates had been installed.
