Belzona helps in the Restoration of an Irrigation Pipeline

ID: 8049

Restoring an old irrigation pipeline within a pumping station.

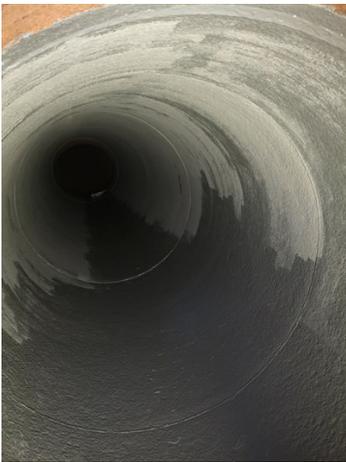
The internal walls of the pipeline were suffering from severe corrosion and wear over time. Outright replacement of the pipe wasn't an option as the pipeline was buried 10 meters below ground and embedded within a concrete structure.

- * View after sandblasting ,
- * Application of Belzona 1121 ,
- * Application of Belzona 1982/9381 ,
- * Application of Belzona 5821 ,

This application was carried out in accordance with system leaflet TCC-05. The internal walls of the pipeline were sandblasted and

then any pitted areas were filled in with Belzona 1121. A Belzona SW2 system was then fabricated to create a "pipe within a pipe" to restore the existing pipeline. Finally 2 coats of Belzona 5821 was applied over the SW2 system to provide corrosion and erosion resistance.
