# Belzona Cold Plate Bonding Repairs & Reinforces Silos

Industry: *Mining & Quarrying*  
Application: *TCC-Tanks and Chemical Containment Areas*  
Substrate: *Carbon steel.*  
Products: *\* Belzona 1111 (Super-Metal) ,  
\* Belzona 1121 (XL Super-Metal) ,*

Customer Location: *Western Australia.*  
Application Date: *June 2018*

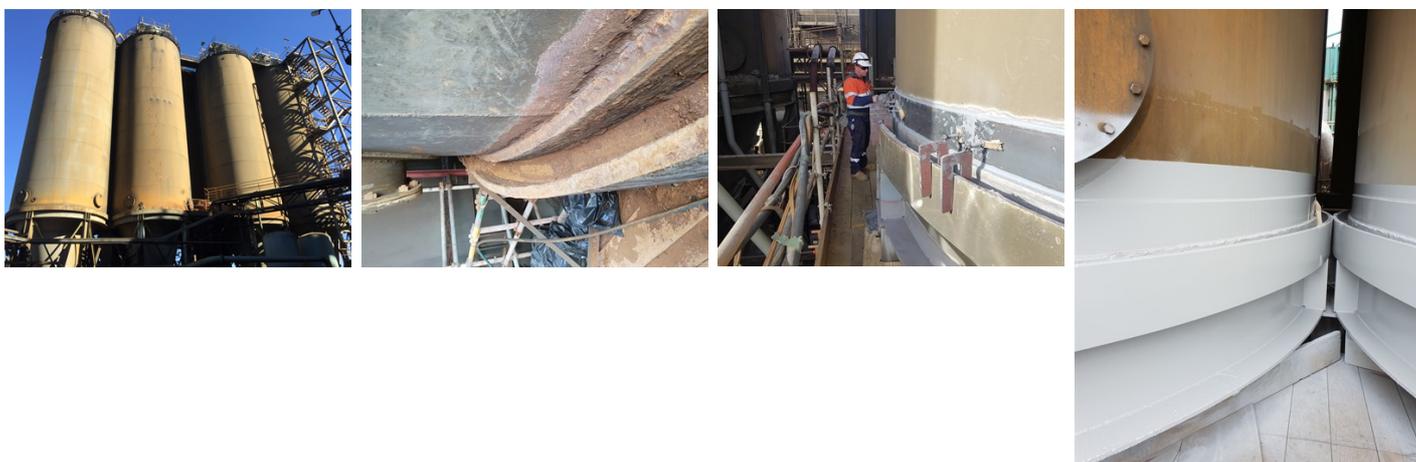
*Inspections were carried out on the Silos and they were found to have severe corrosion loss to bottom sections of all Silos. To empty each Silo would have been a major cost and because the Silos are internally coated welding was not an option.*

- \* 1. The 8 x Nickel Storage Silos ,
- \* 2. Pitted and corroded Silo wall. ,
- \* 3. Plates in place going around the Silo. ,
- \* 4. Completed application. ,

The application was carried out by Cold Bonding 200mm x 1m rolled plates with Belzona in accordance with the Method Statement for Cold Plate Bonding. After abrasive blasting, all corrosion holes were first repaired by filling with Belzona 1111. Belzona 1111 was then applied to the plates which were bonded into place. Belzona 1121 was used when temperatures rose above 35 C to allow more working time.
