Anti-corrosion Protection by Belzona

ID: 8052

Industry: Chemical & Petrochemical
Application: TCC-Tanks and Chemical Containment Areas

Anti-corrosion protection of a sulfuric acid tank together with the existing infrastructure.

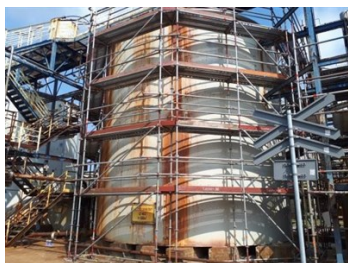
Degradation of the existing anti-corrosion system and rapidly progressing corrosion of steel. Exposure to UV rays and atmospheric precipitation. A very aggressive chemical industry environment and fumes of sulfuric acid. Periodic pouring with sulfuric acid of 97% concentration and 40C temperature.

- * Corrosion of the sulfuric acid tank ,
- * Application of the chemical resistant composite Belzona 5811 ,
- * Application of the topcoat layer of Belzona 5111 ,
- * Application Complete ,

The application was completed in accordance with Belzona System Leaflet TCC-5. Abrasive blasting of steel constructions to a Sa 2.5 degree of purity and a corresponding roughness profile. Dismantling and degreasing the steel structure of the tank.
