BELZONA SEAL A TANK APPLICATION ON CRUDE STORAGE TANK AT A REFINERY

ID: 8108

Customer Location: *Refinery, Mumbai, India*

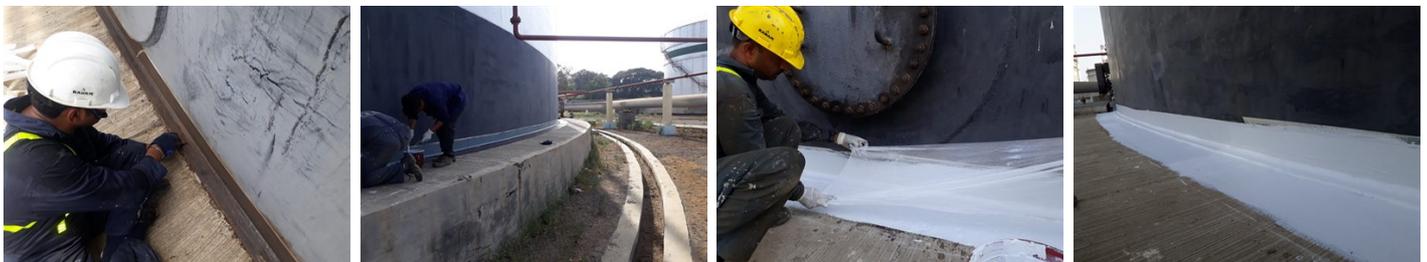
Photograph Descriptions

Water ingresses through the crack between the concrete foundation and tank base. The location of tank is near the sea shore, so presence of high moisture levels accelerates the corrosion at the bottom plate of the tank.

- * Surface preparation done on the shell and concrete base of the tank ,
- * Conditioner applied on the concrete base and the shell of the tank ,
- * Belzona 3111 along with Belzona 9311 was applied on the prepared surface of the tank ,
- * Final layer of Belzona 3111 has been applied and tape is ready for removal ,

Painting was removed from the shell upto a height of 0.2 meter from the base. The concrete was also cleaned and the surface was made clean dry and rough. Belzona 3911 (PSC) was applied on the concrete surface, Belzona 3921 (GSC) was applied on the cleaned metallic surface of the tank. Belzona 3111 was applied on the prepared surface. Belzona 9611 along with Belzona 3111 was applied. After the application gets cured, a final layer of Belzona 3111 was applied.
