BELZONA PROTECTS HYDRAULICS ON WORLDS FIRST TIV

Customer Location: Turbine Installation Vessel, Teesside, UK
Application Date: November 2019

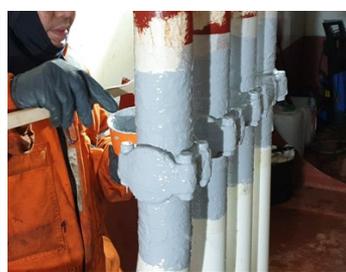
- * 1. Turbine Installation Vessel in action ,
- * 2. 78mm diameter hydraulic pipework ,
- * 3. First coat of Belzona 3412 in progress ,
- * 4. Peelable protection completed ,

Hydraulic pipe fittings.

The application was carried out in accordance with Belzona System Leaflet GSS-11. The Belzona 8411 was applied to release the areas of the fittings, before coating Belzona 3412 over the area and extending 125mm onto each side of the pipework.
