BELZONA PROTECTS HYDRAULICS ON WORLDS FIRST TIV

ID: 8139

Customer Location: Turbine Installation Vessel, Teesside, UK
Application Date: November 2019

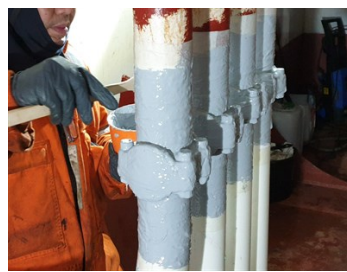
- * 1. Turbine Installation Vessel in action ,
- * 2. 78mm diameter hydraulic pipework ,
- * 3. First coat of Belzona 3412 in progress ,
- * 4. Peelable protection completed ,

Hydraulic pipe fittings.

The application was carried out in accordance with Belzona System Leaflet GSS-11. The Belzona 8411 was applied to release the areas of the fittings, before coating Belzona 3412 over the area and extending 125mm onto each side of the pipework.
