# Belzona Protects New Sea Water Pumps

Industry: Water / Wastewater  
Application: CEP-Centrifugal Pumps  
Substrate: Steel  
Products: \* Belzona 1341 (Supermetalgilde) ,

Customer Location: Lancashire, UK  
Application Date: January 2019

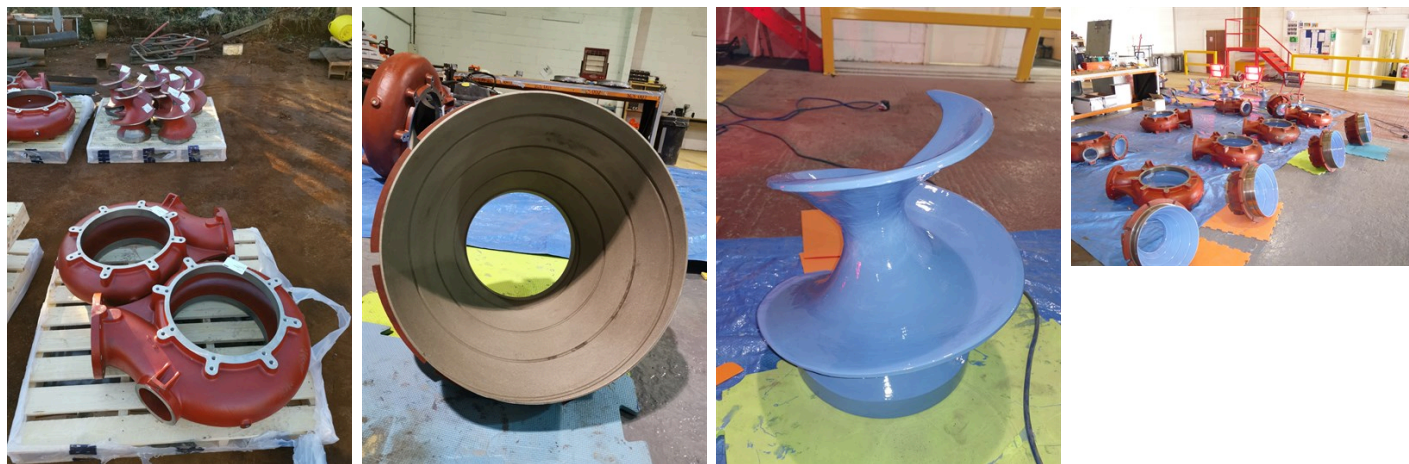
*New pumps requiring internal protection prior to going into service*

- \* New pump components delivered for protection ,
- \* Pieces grit blasted ,
- \* Completed application of one of the pieces ,
- \* Completed application ,

The application was undertaken in accordance with CEP-01. The pumps were delivered to the Belzona workshop in Wrexham where the team grit blasted the components to SA 2 ½ with a minimal profile of 75 microns. Each of the internal areas were then coated with two coats of Belzona 1341 and allowed to cure prior to returning to the client.
