# Chemical Resistant Belzona Lining Applied to Interior of Mixer Drum

**Industry:** General Industry  
**Application:** TCC-Tanks and Chemical Containment Areas  
**Substrate:** Steel  
**Products:** \* Belzona 1111 (Super Metal) ,  
\* Belzona 4341 (Magma CR4) ,

**Customer Location:** Chemical Manufacturer, Bristol, UK  
**Application Date:** December 2018

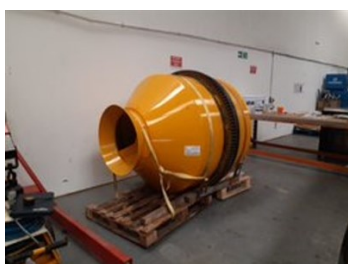
- \* 1. Mixer drum delivered to workshop ,
- \* 2. Internal substrate prepared ,
- \* 3. Voids between blades filled ,
- \* 4. Completed lining ,
