# Chemical Resistant Belzona Lining Applied to Interior of Mixer Drum

**Industry:** General Industry  
**Application:** TCC-Tanks and Chemical Containment Areas  
**Substrate:** Steel  
**Products:** \* Belzona 1111 (Super Metal) ,  
\* Belzona 4341 (Magma CR4) ,

**Customer Location:** Chemical Manufacturer, Bristol, UK  
**Application Date:** December 2018

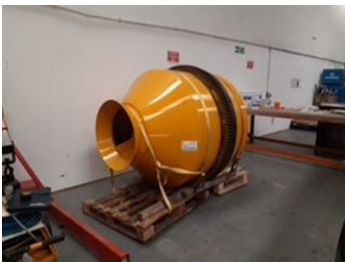
- \* 1. Mixer drum delivered to workshop ,
- \* 2. Internal substrate prepared ,
- \* 3. Voids between blades filled ,
- \* 4. Completed lining ,

Newly fabricated mixer drum (2.2m length x 1.5m diameter) used in a chemically aggressive process.
