Protection of a brand new secondary containment area with Belzona

ID: 8170

Industry: Chemical & Petrochemical
Application: FPA-Floor Problem Areas
Substrate: Concrete
Products: * Belzona 4181 (AHR Magma Quartz) ,

Customer Location: Chemical Company - France
Application Date: January 2020

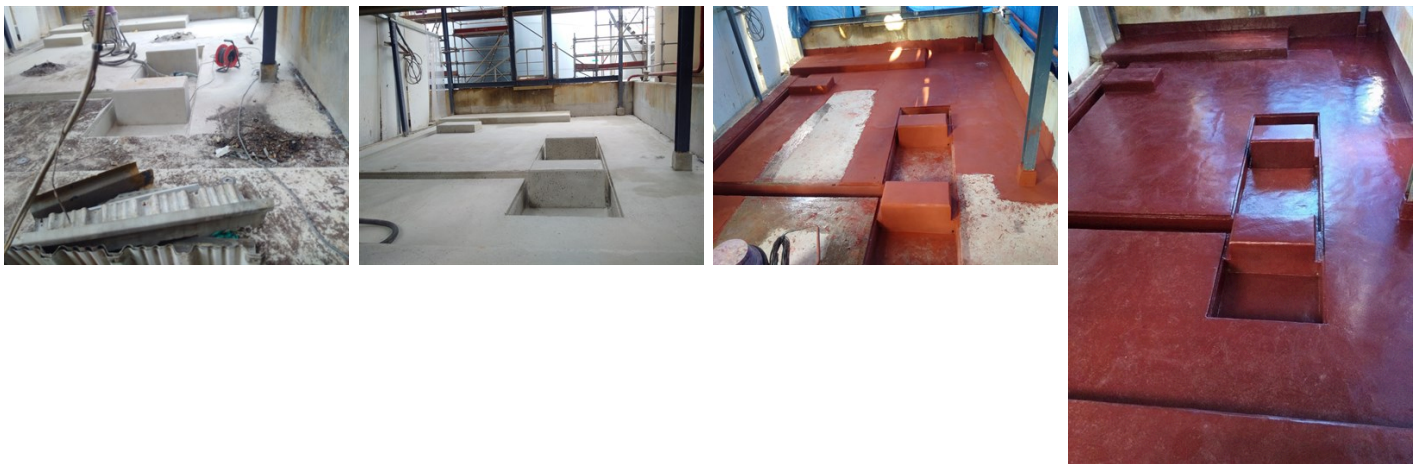
Photograph Descriptions

- * 1 - Secondary containment area newly created ,
- * 2 - Area after surface preparation ,
- * 3 - During the application ,
- * 4 - Area completely coated and protected with Belzona 4181 ,

Brand new secondary containment area 216m2 where reactor pumps with hydrochloric acid at 80°C will be installed.

The area was cleaned and prepared before that the application of Belzona 4181 was completed in accordance with Belzona System Leaflet FPA-03.

Belzona 4181 had successfully passed all the client tests (especially the high temperature) for this plant where they produce synthetic salt. Area of 216 m2, carried out in 5 days for a 4 men team. Overall cost 74,000€.
