BELZONA SEALS OPEN DRAIN

ID: 820

Industry: Chemical & Petrochemical
Application: TCC-Tanks and Chemical Containment Areas
Substrate: Concrete
Products: * Belzona® 4131 (Magma-Screed) ,
* Belzona® 5811 (Immersion Grade) ,

Customer Location: Chemical Manufacturer (Chromium)-UK
Application Date: July 2006

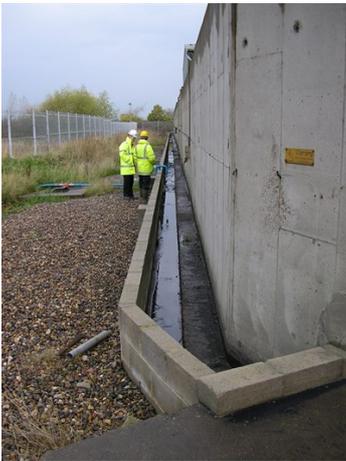
Under heavy rain the drain leaks through the concrete base/block interface & through the porous blocks themselves.

- * General view of open drain ,
- * Belzona® 5811, first coat ,
- * Belzona® 5811, second coat ,
- * The completed application ,

The application was carried out in accordance with Belzona Know-How System Leaflet TCC-15. The drain was pressure washed to remove any dirt & contaminants and allowed to dry. A fillet of Belzona® 4131 was formed along the base/wall interface followed by two coats of Belzona® 5811.
