BELZONA SEALS OPEN DRAIN

ID: 820

Customer Location: Chemical Manufacturer (Chromium)-UK
Application Date: July 2006

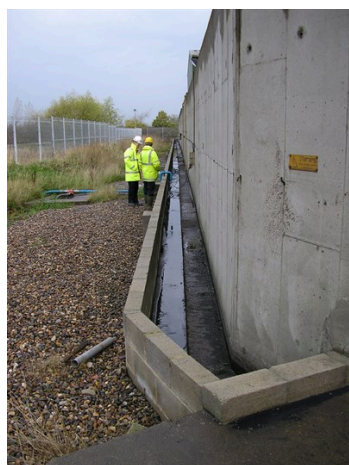
Under heavy rain the drain leaks through the concrete base/block interface & through the porous blocks themselves.

- * General view of open drain ,
- * Belzona® 5811, first coat ,
- * Belzona® 5811, second coat ,
- * The completed application ,

The application was carried out in accordance with Belzona Know-How System Leaflet TCC-15. The drain was pressure washed to remove any dirt & contaminants and allowed to dry. A fillet of Belzona® 4131 was formed along the base/wall interface followed by two coats of Belzona® 5811.
