# Belzona® Composite repair On-site Application for Buried Natural Gas Pipelines

Industry: Oil & Gas  
Application: VPF-Valves, Pipes and Fittings  
Substrate: Carbon steel  
Products: \* Belzona 1161 (Super UW-Metal) ,  
\* Belzona 9371 (Reinforcement Sheet) ,

Customer Location: Sichuan, China  
Application Date: August, 2013

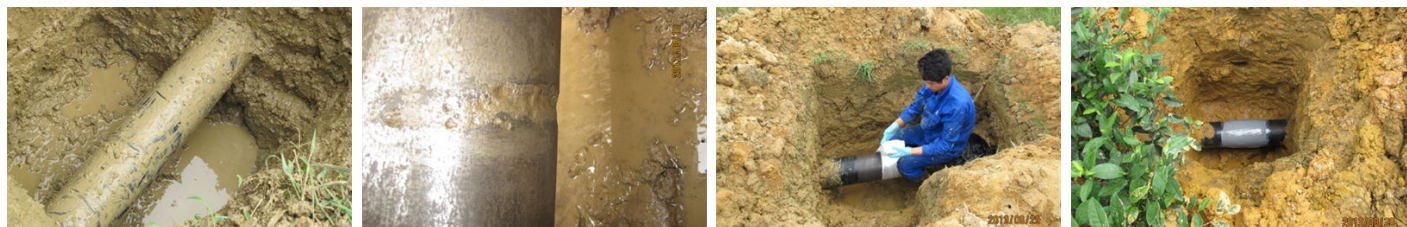
## Photograph Descriptions

The operating pressure of these buried gas pipelines is 2Mpa; Maximum depth of external metal loss is 6.7mm; The corrosion area is 40 × 60mm. These pipelines have been immersed in a humid environment for a long time, and the surface of the pipeline cannot be dried.

- \* 1. Buried pipeline☐ ,
- \* 2. Damaged external surface☐ ,
- \* 3. Dry wrapping of the reinforcing sheet; ,
- \* 4. Application complete ,

As these buried gas pipelines operate in humid environments (such as paddy fields and hills area), Belzona moisture tolerant material is used for on-site application which avoids hot-work and saves time and costs for client. The client is very pleased with the result.
