Belzona Apply Protective Treatment to New-Build Properties

Application: WPA-Wall Problem Areas

Substrate: Brick

Products: * Belzona 5122 (Clear Cladding Concentrate) ,

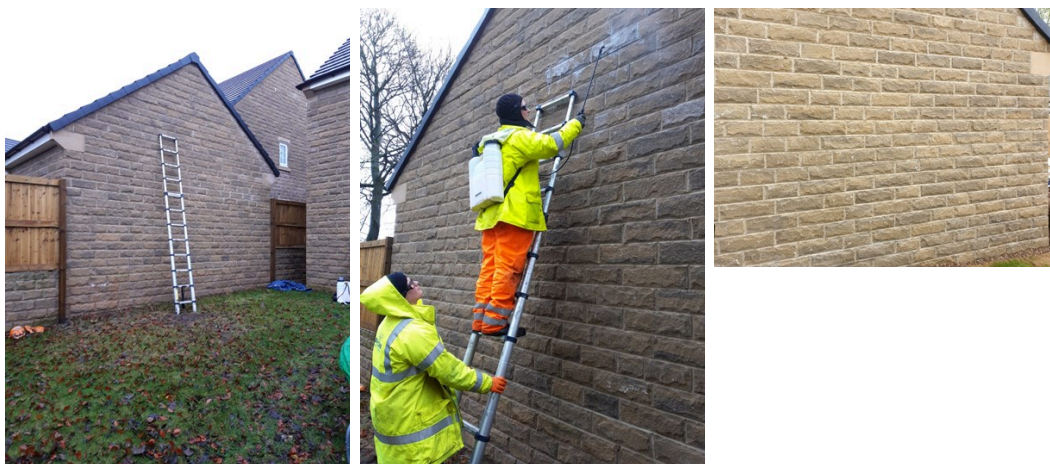
Photograph Descriptions

There was an unforeseen amount and severity of inclement weather in the area which had caused the garages to leak considerably.

- * Garage wall to be treated ,
- * Application in progress ,
- * Application completed on one garage ,

The home builders had constructed the garages of a new housing development with only a single skin of bricks. There had been several high-level complaints from the homeowners on the issue. The client originally tried a competitor material to rectify the issues but in many cases this product was ineffective!

Belzona 5122 was applied in accordance to Belzona Know-How System Leaflet WPA-8. Protective sheeting and tape was applied to all areas not being treated such as paths, plant life and windows near the application area. Belzona 5122 was then diluted at a ratio of 7:1 and put into a standard sprayer. Belzona 5122 solution was then sprayed onto the brickwork. Starting at the lowest part of the wall and applying upwards towards the highest section.

The application was undertaken by Belzona, specialist contractors in the UK. The home builder was very pleased with the outcome of the treatment and has named Belzona as their preferred supplier of this type of repair material. Since this application, 50 garages on this development have been treated with several others across the UK also taking place.
