Belzona Protects Sewage Separator of A New Project

ID: 8254

Industry: Water / Wastewater
Application: TCC-Tanks and Chemical Containment Areas
Substrate: Carbon steel
Products: * Belzona 5892 ,
* Belzona 1511 (Super HT Metal) ,

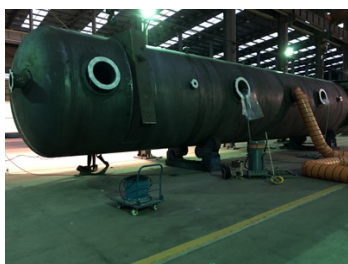
- * The process vessel ready for application ,
- * Spray applying the first layer of Belzona 5892 ,
- * Spray applying the second layer of Belzona 5892 ,
- * Application complete ,

Application carried out in accordance with Belzona Know-How System Leaflet TCC-5. Belzona 5892 was spray applied on main areas and brush applied on small areas where spraying is inconvenient.
