# Belzona Protects New-build Separator

ID: 8255

Industry: Oil & Gas  
Application: TCC-Tanks and Chemical Containment Areas  
Substrate: Carbon steel  
Products: \* Belzona 5892 ,  
\* Belzona 1391T ,

Customer Location: China  
Application Date: 2019

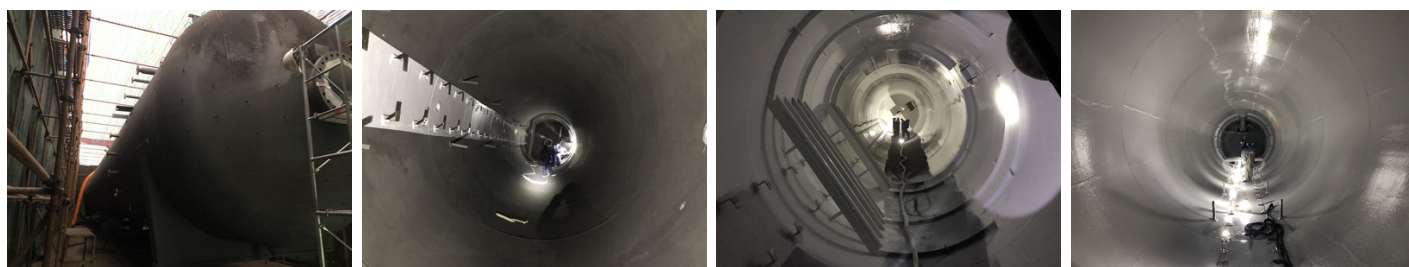
- \* Exterior of the separator ,
- \* Pre-coating Belzona 1391T ,
- \* Spray applying Belzona 5892 ,
- \* Application complete ,

Application carried out in accordance with Belzona Know-How System Leaflet TCC-5. The erosion area at the bottom of the separator and the brackets are protected with high-temperature erosion-corrosion resistance coating—Belzona 1391T, while other large areas are spray-coated with Belzona 5892.
