Belzona Protects New-build Separator

Industry: Oil & Gas
Application: TCC-Tanks and Chemical Containment Areas
Substrate: Carbon steel
Products: * Belzona 5892 ,
* Belzona 1391T ,

Customer Location: China
Application Date: 2019

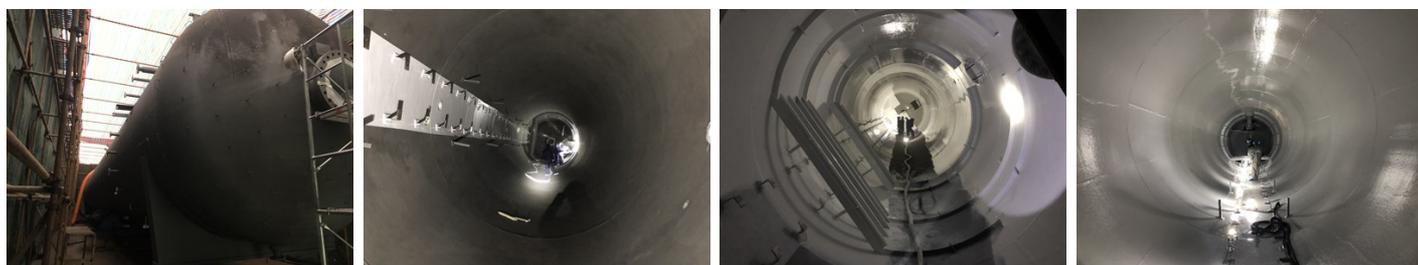
Photograph Descriptions

- * Exterior of the separator ,
- * Pre-coating Belzona 1391T ,
- * Spray applying Belzona 5892 ,
- * Application complete ,

Application carried out in accordance with Belzona Know-How System Leaflet TCC-5. The erosion area at the bottom of the separator and the brackets are protected with high-temperature erosion-corrosion resistance coating—Belzona 1391T, while other large areas are spray-coated with Belzona 5892.
