Belzona Protects New-build Separator for Natural Gas Plant

ID: 8256

Industry: Oil & Gas
Application: TCC-Tanks and Chemical Containment Areas

Customer Location: China
Application Date: 2019

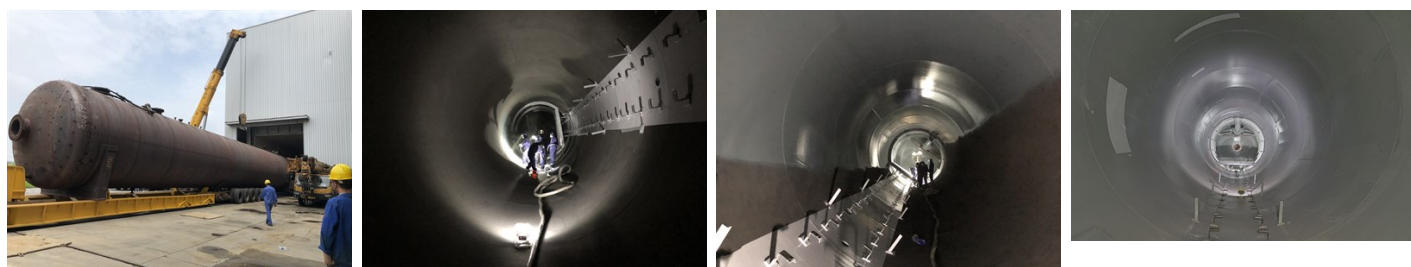
Photograph Descriptions

- * Exterior of the separator ,
- * Pre-coating Belzona 1391T ,
- * Spray applying Belzona 1391S ,
- * Application complete ,

Application carried out in accordance with Belzona Know-How System Leaflet TCC-5. The erosion area at the bottom of the separator and the brackets are protected with high-temperature erosion-corrosion resistance coating, Belzona 1391T, while other large areas are spray-coated with Belzona 1391S.
