Belzona Repairs and Protects 18 Chillers

Application: *HEX-Heat Exchangers*

Tubesheet and Water boxes of Chiller units

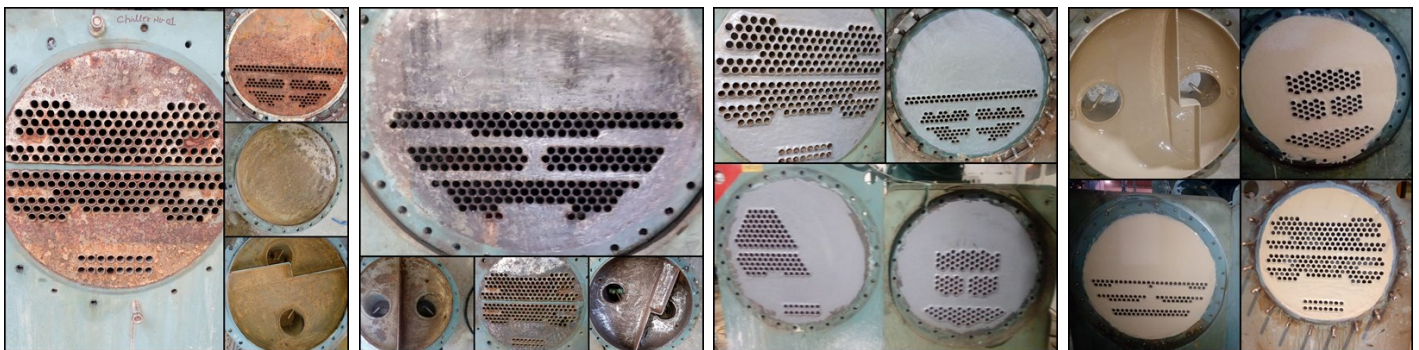
Tubesheet and water box surfaces of 10 Chillers of a Plastic Plant's HVAC system were corroded over time. The client had purchased 8 new chillers for a new HVAC system and had planned to replace the 10 chillers in phases. Customer needed a cost effective solution.

- * Old Chiller with tubesheet and water boxes ,
- * Chiller under process of being cleaned ,
- * Chiller resurfaced with Belzona 1111 ,
- * Chiller coated with Belzona 5811 ,

Application carried out in accordance with Belzona Know-How System Leaflets HEX-1 & -3. After corking tubes, Belzona® 1111 used to ensure the tubes are flush with the surface before applying the Belzona 5811 system.

As max temp of water in the chiller was 40 deg.C, Belzona 5811 was selected considering the price point. By applying the protective coating at the factory the customer was able to prevent much of the damage caused by day to day operation of the equipment and

extend the life. The Belzona application saved the equipment from replacement. Initially the application was done only on 3 chiller units. Seeing the cost saving and life extension, the customer placed order for rest of the 7 old chillers and 8 new chillers.
