BELZONA KEEPS ENTRANCE WAY NICE AND SAFE

Customer Location: Theme Centre, Doncaster, UK

Application: FPA-Floor Problem Areas

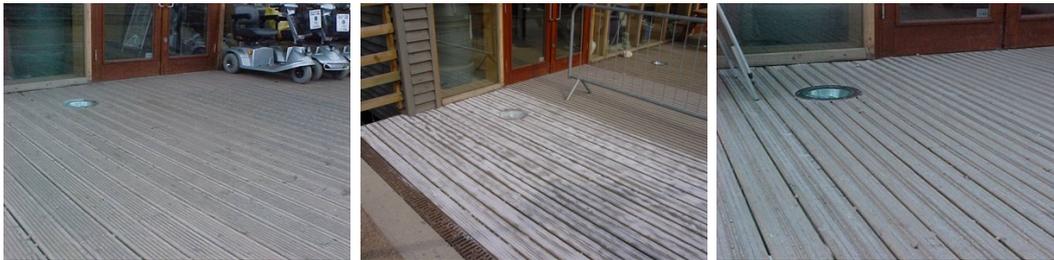
Photograph Descriptions

Slippage problem, especially on the main entrance of the building. The client had tried unsuccessfully to combat the problem by nailing chicken wire to the timber decking, which caused extra trip hazards.

- * Slippage problem area. ,
- * After masking 2 out of 6 grooves, Belzona® 5811 was mixed with 50% aggregate applied. ,
- * Masking being removed from completed application. ,

The application was carried out using a modified version of the Belzona Know-How System Leaflet FPA-8. The Belzona® 5811 was mixed with 50% of Belzona® 9221.

Following this initial area being treated a water spillage occurred half on the decking and half on the Belzona Deck Grip. It was noted that the timber decked area was extremely slippery and hazardous whereas the area covered with the Belzona Deck Grip gave excellent grip properties even when soaked with water.
