Belzona Refurbishes old weathered industrial roof

ID: 8280

Customer Location: *Miami, Florida. USA*
Application Date: *April 2020*

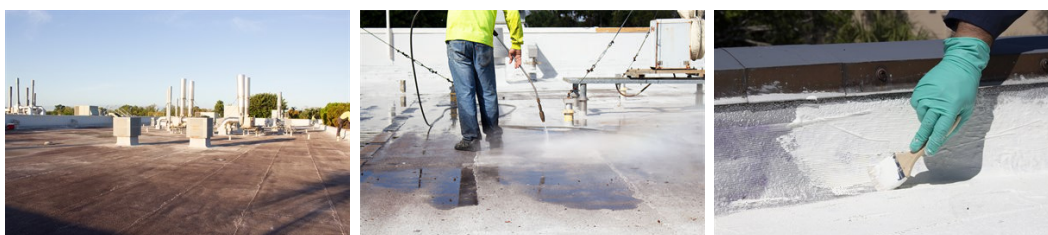
Photograph Descriptions

Numerous water leaks and deteriorated roof

- * Roof before product application ,
- * Surface preparation via pressure cleaning ,
- * Mesh being applied over joint ,
- * The finished area ,

Application was carried out in accordance with Belzona Know-How System Leaflets RPA-1 and RPA-8. Surface was cleaned via pressure washing. Belzona 3911 was applied with a brush as a primer over the entire roof and belzona 3921 was applied over any metallic substrate. Belzona 3111 was spray applied over the horizontal surfaces and brush applied over seams and difficult geometries. Belzona 9311 sheet was additionally applied to problem areas such as joints, seams and glazing bars as additional reinforcement.
