# BELZONA REPAIRS LEAKING ROOF AT UNIVERSITY

ID: 8285

Industry: Buildings & Structures  
Application: RPA-Roof Problem Areas  
Substrate: Mineral Felt  
Products: \* Belzona 3131 (WG Membrane) Belzona 4141 (Magma-Build) ,

Customer Location: University Campus, North Wales  
Application Date: January 2020

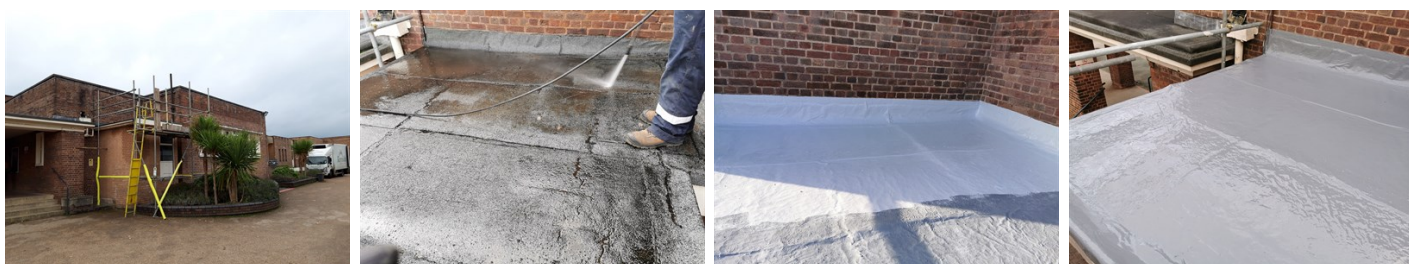
A small felt roof over a section of the canteen was in need of repair. The felt system had degraded to the point where rainwater is now entering the building.

- \* University canteen roof ready for repair ,
- \* Surface preparation in progress ,
- \* Application of Belzona 3131 in progress ,
- \* Completed application ,

The repair area was pressure washed substrate leaving a clean sound surface. Fungicidal wash was then be scrubbed into the surface and left to dry as per instructions. Localised concrete repairs to the flashings were then completed using Belzona 4141. Two coats of Belzona 3131 incorporating reinforcing sheet were then applied to complete the application. Belzona 9361 reinforcing sheet was used on general roof areas and Belzona 9351 reinforcing sheet on problem areas where exceptional elasticity is required such as the upstands. The application was carried out in accordance with Belzona Know-How System Leaflet RPA-7 and RPA-8.
