# Fairleads Assembly With Belzona

ID: 8300

Industry: *Marine*  
Application: *SOS-Ships and Offshore Structures*

Substrate: *Aluminum housing and Stainless Steel fairlead*  
Products: *\* Belzona 1111 (Super Metal) ,*  
*\* Belzona 5811 (Immersion Grade) ,*

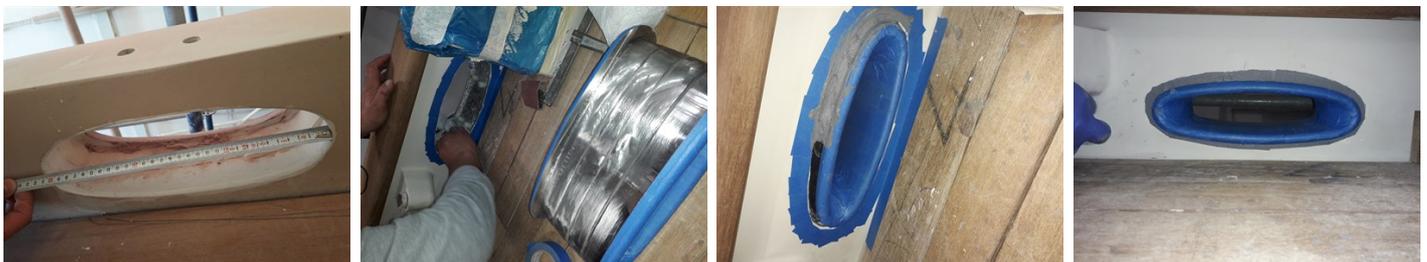
*Conventional methods of installation fairleads result in voids between the fairlead and housing. Bi-metallic corrosion may occur between aluminum body and stainless steel equipment used.*

- \* Before application ,
- \* After surface preparation ,
- \* Application of Belzona ,
- \* After Belzona application ,

Application was carried out in accordance with Belzona Know-How System Leaflet SOS-08. Application surfaces was prepared to achieve SA2½ cleanliness. Aluminum housing inner surface and stainless steel fairlead exterior surfaces cleaned. The fairlead is aligned to the aluminum housing mechanically. Sealing and assembly was done with Belzona 1111. The void in the fairlead pocket was filled with Belzona 5811 by injection method.
