# Belzona Protects a Floor of a leading European company.

ID: 8303

**Industry:** *General Industry* **Customer Location:** *Switzerland*  
**Application:** *FPA-Floor Problem Areas* **Application Date:** *2019*  
**Substrate:** *Concrete*  
**Products:** *\* Belzona 5811 was selected due to the large floor area and allowing this product to be spray applied whilst also offering chemical resistance, incorporating a broadcast of aggregate for a slip resistant finish. Belzona 4521 was used as an Elastomeric sealing system for the expansion joints. ,*

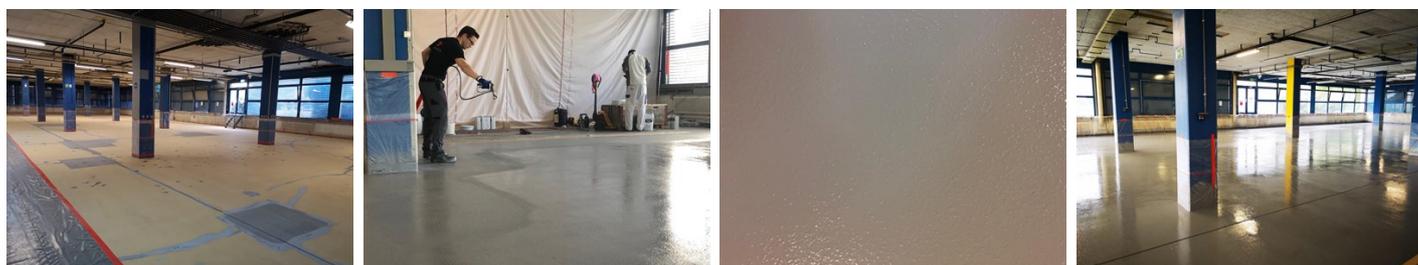
*The large floor area had cracked as the concrete did not allow for any expansion joints. When the concrete expanded the concrete had cracked in multiple places leaving the client with healthy and safety issues.*

- \* Floor Preparation ,
- \* Airless Spraying of Belzona 5811 ,
- \* Close up of incorporated aggregate ,
- \* Complete Job ,

The concrete substrate was abraded to expose the aggregate, the surface was sprayed with Belzona 5811 using airless spraying equipment in accordance with Belzona System Leaflet FPA-3. The expansion joints were filled using Belzona 4521 in accordance with Belzona System Leaflet FPA-6
