# BELZONA SAVES PLANT \$400,000 PER WEEK

Industry: *General Industry*  
Application: *TCC-Tanks and Chemical Containment Areas*

Customer Location: *Mineral Processing Plant in South Texas*  
Application Date: *Nov/Dec 2006*

## Problem

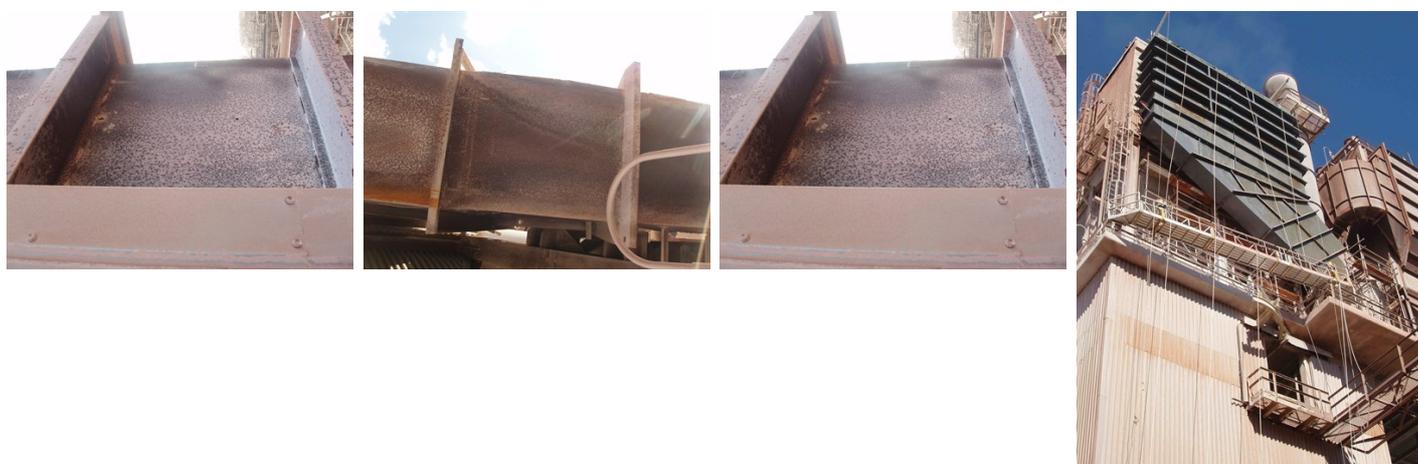
*Air intrusion into ductwork seriously affected plant efficiency*

- \* Ductwork before work commenced ,
- \* Close up of framework showing loose connections ,
- \* Another view of framework showing loose connections ,
- \* Finished application ,

The steel ductwork had become corroded from salt water spray and NAOH mist. Vibrations from operations caused sections to become disbonded from the framework.

Application carried out in accordance with Belzona Know-How System Leaflet TCC-5. Belzona® 1111 and 1121 were used to bond loose metal to framework when system was out of service and cool. System was then brought up to operating temperature and

Belzona® 5851 was used to coat the repaired areas and the entire surface to prevent further corrosion.
