Rubber lined ionization chamber repaired with Belzona

ID: 8320

Damage of the original rubber lining of an ionization tower

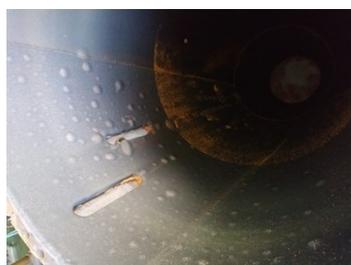
- * Damaged rubber lining ,
- * Removing of damaged lining and surface preparation ,
- * Second layer of 2121 is being applied ,
- * Finished application ,
