# BELZONA REPAIRS AND SECURES FLOORS AND STAIRS

ID: 833

Application: *FPA-Floor Problem Areas*

Customer Location: *Housing association, Georgia, US*

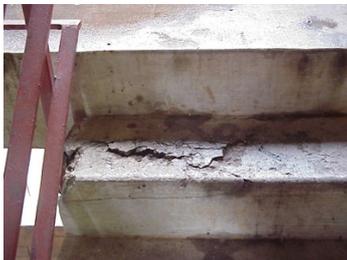
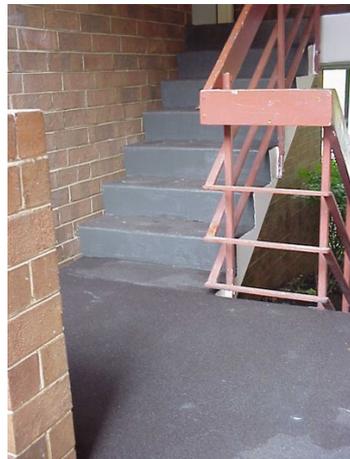
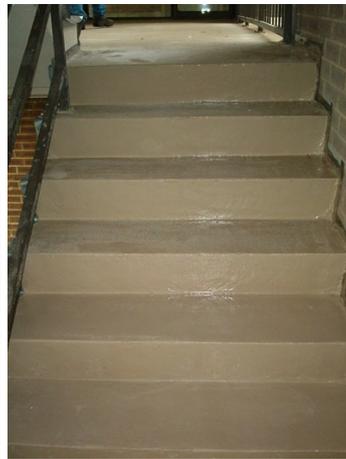
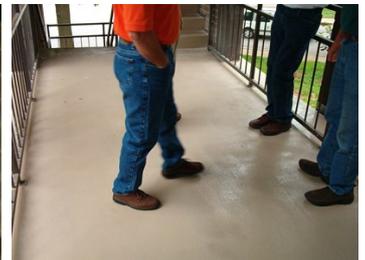
*Spalled concrete due to water damage over time.*

- \* Damaged stairs. ,
- \* Completed repairs and coating, with Belzona® 5811 mixed with a light coat of sand. Undersides of the stairwell were coated with Belzona® 3111. ,
- \* Areas repaired with Belzona® 4111 & 4141. ,
- \* Finished view of the project. ,

The worn concrete in this public building had become a health and safety hazard. Damaged areas were rebuilt with Belzona® 4111 & 4141. The underside of the stairwells was coated with Belzona 3111 to prevent moisture from entering the concrete. Belzona® 5811 was used to protect the stairs and balconies, and a non-slip system was created by incorporation of aggregates mixed into the Belzona® 5811. Three years later, this application was still in great condition with only a few areas needing to be touched up.
