## Belzona distributor's oven helps for quick return to service

ID: 8392

**Industry:** Chemical & Petrochemical  
**Application:** TCC-Tanks and Chemical Containment Areas  
**Substrate:** Carbon steel  
**Products:** Belzona 1391T,

**Customer Location:** Bratislava, Slovakia  
**Application Date:** 2019

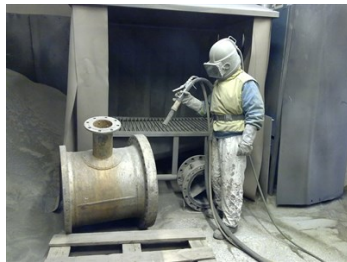
Erosion and Corrosion to the exchanger parts required repairing.

Blasting and cleaning.

The coated equipment was placed in the oven. The temperature was raised so that the coating was heated to a minimum 50°C for 1 hour.

After blasting and cleaning, the parts of exchangers were coated with Belzona 1391T. The application was performed in accordance with Belzona system leaflet TCC-5. The distributor had prepared an oven in a concrete garage with glass cladding insulation, with heating and remote temperature control. The coated equipment was placed in the oven. The temperature was raised so that the coating was heated to a minimum 50°C for 1 hour.
