# Belzona Protects Operators in a Sugar Refinery using Belzona 5871

ID: 8408

Industry: Sugar  
Application: VPF-Valves, Pipes and Fittings  
Substrate: Stainless Steel - Grade 316  
Products: \* Belzona 5871 Belzona 9111 ,

Customer Location: L'Aube region of France  
Application Date: September 2020

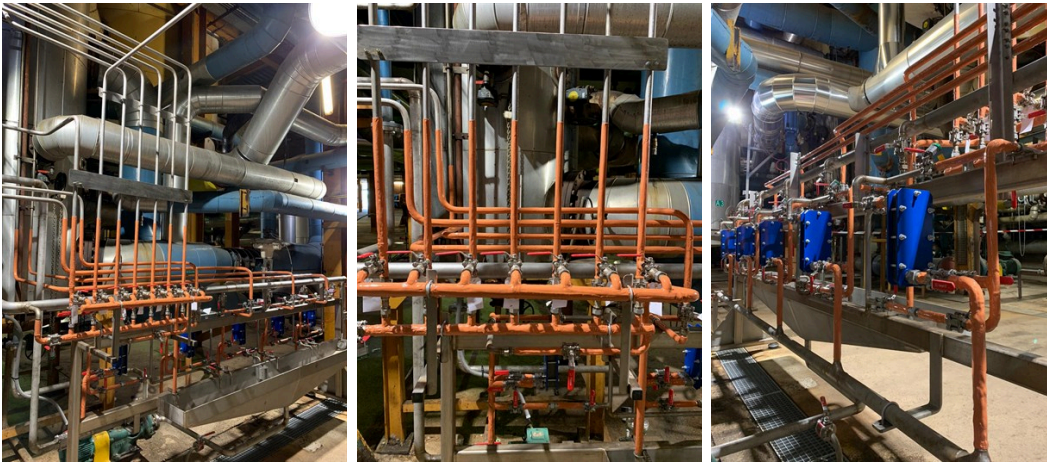
## Photograph Descriptions

Operator safety was a major concern for the asset owners, when their operators are having to manually operate the purge valves due to the pipework transporting steam at 90°C, therefore being a hazard and exposing the operators to potentials burn incidents. The internal microcavities obtained by the system as it expands, creates a high performance thermal barrier, insulating the thermal process and/or preserving the safety of the operators. The new contact temperature after using Belzona 5871 was 47°C.

\* 1) Belzona 5871 Final System Backside near Walkway 2) Belzona 5871 Final System Backside near Walkway (Close-Up) 3) Belzona 5871 Final System Purge Valve Access ,

The application was done in accordance with a modified version of Belzona's VPF System Leaflets. Belzona 5871 was manually applied using a brush no larger than 20mm wide, with the bristles cut down to 25mm. The product was applied to achieve a thickness of of 6mm.
