Belzona Restores Concrete Settlement Tank Walls

Industry: Water / Wastewater
Application: TCC-Tanks and Chemical Containment Areas
Substrate: Concrete
Products: * Belzona 4131 (Magma-Screed) ,
* Belzona 2211 (MP High-Build Elastomer) ,

Customer Location: Lancashire, UK
Application Date: October 2020

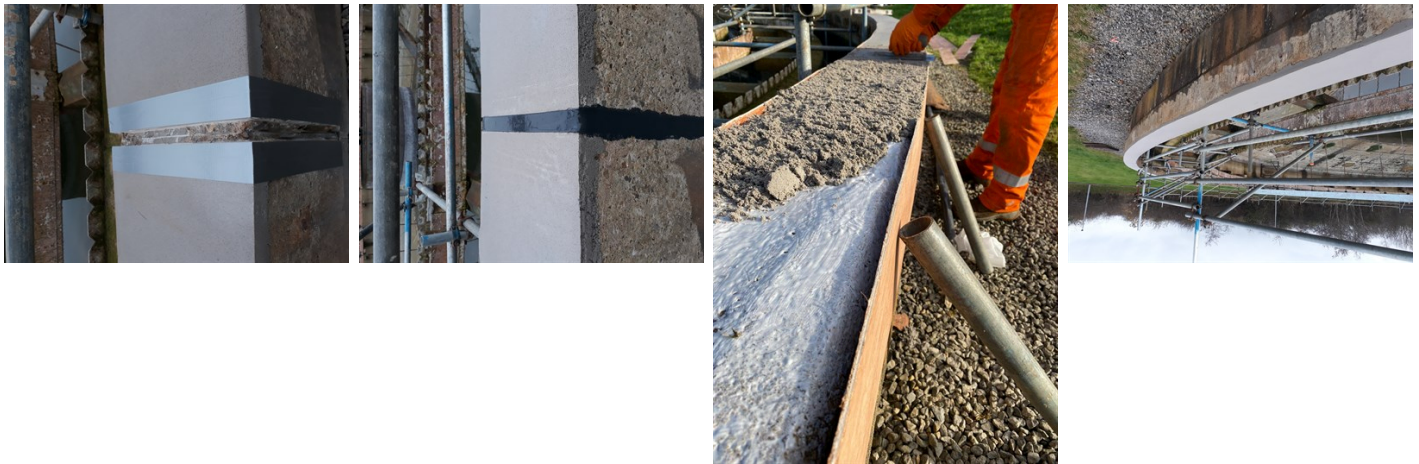
Photograph Descriptions

The top of the concrete walls of multiple FST's had suffered from abrasive wear due to the action of the wheels that drive the rotating separator arms. This has been further aggravated by freeze-thaw cycles on the damaged and damp concrete substrate. There has also been damage to expansion joints, which have been repaired previously, but began showing signs of failure.

- * 1 - Expansion joint before repair ,
- * 2 - Expansion joint after repair ,
- * 3 - Belzona 4131 during application ,
- * 4 - Repair completed ,

Belzona 4131 was applied to the top of the walls to create a hard, compression and abrasion resistant surface to provide long term protection and prolong its service life. The expansion joints were removed and replaced with Belzona 2211 to allow for the

expansion/contraction of the concrete. The work was completed in accordance with Belzona System Leaflets TCC-09, TCC-11 & TCC-12.
