# Roller Door Entrance Repair using Belzona

ID: 8436

Customer Location: Huthwaite, UK  
Application Date: September 2020

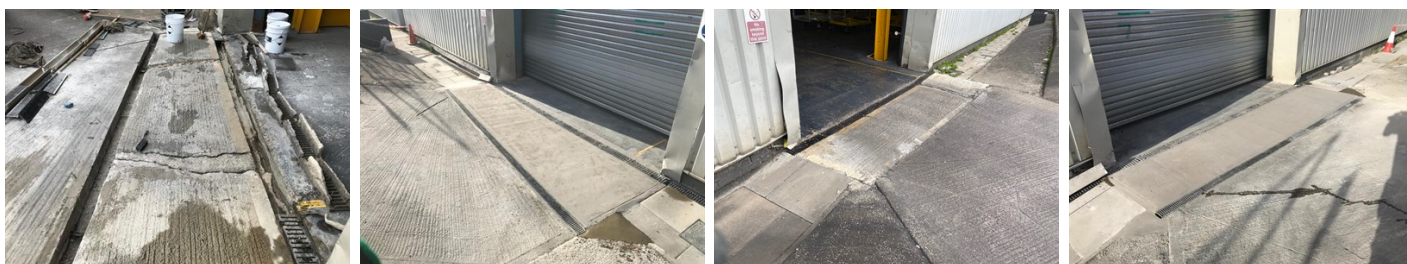
## Photograph Descriptions

A concrete entrance had been compromised by years of wear from fork lift traffic running over a small concrete entrance pad which had suffered cyclic freeze/thaw in the winter, heavy rain and other erosive forces. The existing concrete had become compromised to a limit where it had become a safety hazard to run industrial traffic over the area

\* 1. Prior to repairs 2. Finished application 3. Aco drains installed 4. Aco drains installed ,

The concrete was prepared as per the Belzona 4131 IFU and the application was carried out in accordance with Belzona System leaflet FPA-1. The Aco drain gulleys were dug out and the Aco drains installed. Belzona 4911 was mixed and applied to specification as per the Belzona 4131 IFU. Belzona 4131 was mixed and applied according to the Belzona 4131 IFU. The area was left to cure for the recommended time according to ambient temperatures.
