# Weatherproofing Electrical Zipper Boots The Belzona Way

ID: 8440

Industry: Power  
Application: RPA-Roof Problem Areas  
Substrate: Rubber  
Products: \* Belzona 3121 (MR7) ,  
\* Belzona 1121 (Super XL-Metal) ,  
\* Belzona 9341 (Reinforcement sheet) ,

Customer Location: Decatur, AL  
Application Date: November 2020

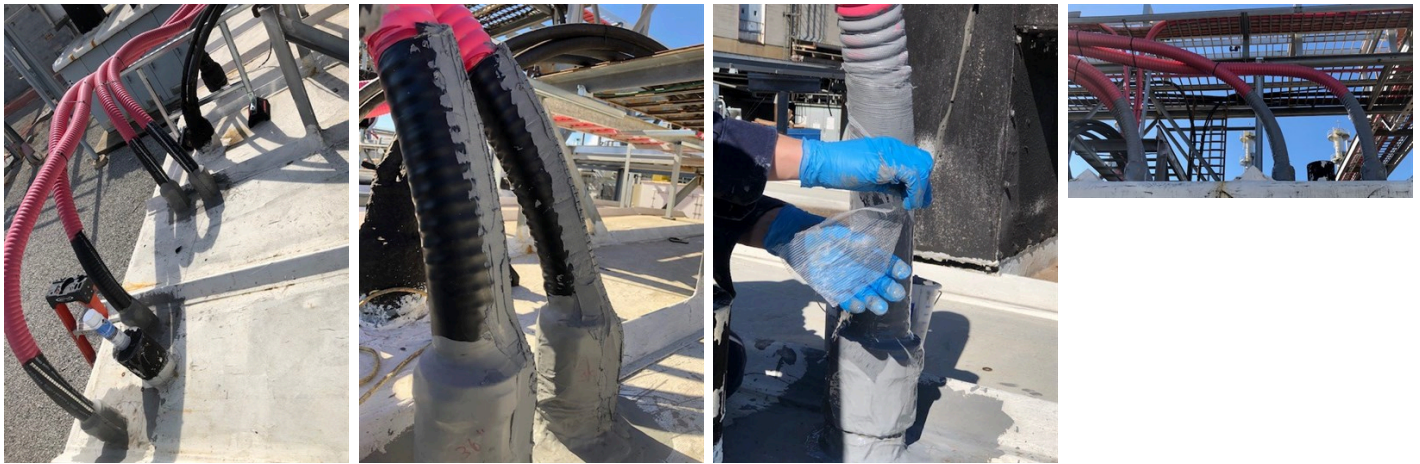
## Photograph Descriptions

Weather deteriorated the original zipper boot causing water penetration inside the panel leading to power failure.

- \* 1. Unprotected electrical zipper boots ,
- \* 2. Applied Belzona 1121 ,
- \* 3. Applying Belzona 9341 and Belzona 3121 ,
- \* 4. Finished weatherproofed electrical boot ,

After removing any loose debris we then cleaned each boot with 9111. We then applied the 1121 to each side of the zipper to create a more uniformed surface area. Once the 1121 cured we then applied a coat of 3121 to the zipper boot. The applying the 9341 wrap at a minimum of thirty-six inches in height. Once the wrap was was competed we then added the final coat of 3121 over the wrap completing the job.
