# Belzona Seals Base of a Storage Tank

ID: 8442

Customer Location: Oil terminal, Grangemouth, Scotland

Application Date: November 2020

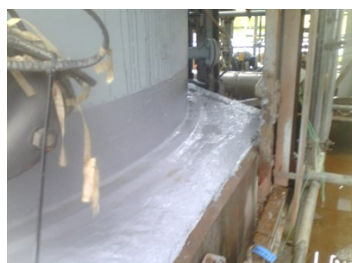
- \* 1 - Work completed around the annular rim ,
- \* 2 - Close up of finished application onto concrete ,
- \* 3 - Completed application covering all three substrates ,

The application was carried out in accordance with Belzona System Leaflet GSS-03. The base of the tank was grit blasted, Belzona 6111 was then applied for corrosion protection on the steel. Bridging tape & Belzona 3921 were applied to allow the top coat to bond in the correct areas, followed by Belzona 3111 as a two coat system for sealing and weatherproofing.
