# Protection Of Biomass Incinerator Chutes With Belzona

ID: 8448

Industry: Mining & Quarrying  
Application: SHM-Solids Handling Machinery

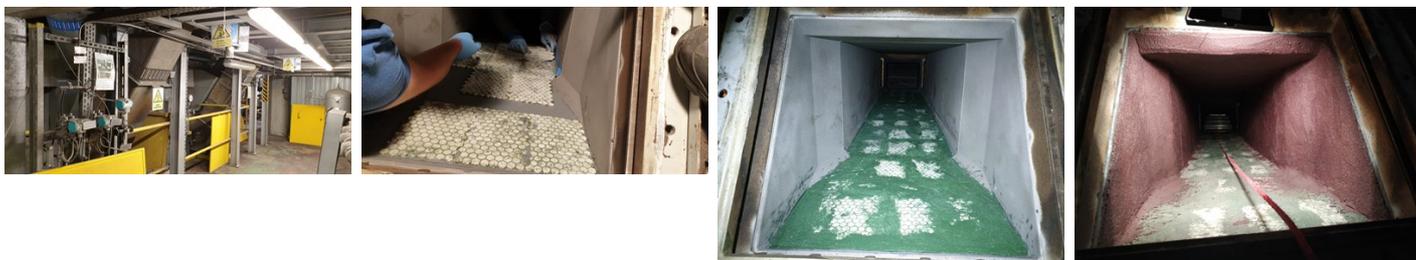
Excessive wear of stainless steel chutes when operating at elevated temperatures. The client was looking for a long-term solution to protect the substrate.

- \* 1. Chutes in the Biomass Plant ,
- \* 2. Application of Belzona 9811 ,
- \* 3. Application of Belzona 1813 grouting Belzona 9811 ,
- \* 4. Complete Application using Belzona 1811 ,

Application inside biomass incinerator chutes (dimension 500x500x2700mm)

Application was carried out in accordance with Belzona system Leaflet SHM-7. After blasting with aluminium oxide grit Belzona 9811 alumina tiles were bonded to prepared substrate using Belzona 1111 and then grouted using Belzona 1813

Premature chutes failure resulted in frequent component replacements and downtime. To prevent such failures in the future and extend the service life of the chutes, the client was looking for a way to protect this sections. This system proved to be the ideal

solution and provided the required abrasion resistance, and the customer was very pleased with the results.
