Belzona Lines High Temperature Ethanol Vessel

ID: 8449

Industry: *Chemical & Petrochemical*
Application: *TCC-Tanks and Chemical Containment Areas*

Customer Location: *Refinery, Scotland*
Application Date: *November 2020*

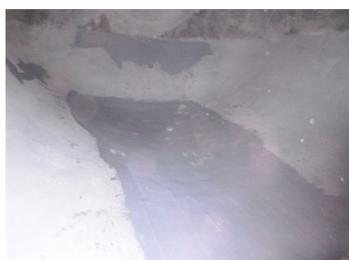
- * 1 - Vessel external ,
- * 2 - Belzona 1511 applied to areas of weld overlay ,
- * 3 - Belzona 1593 first coat ,
- * 4 - Belzona 1593 second coat ,

The vessel was grit blasted to SA2.5 & 75 microns. Any pitted areas were then filled with Belzona 1511. Areas where weld overlay had been applied in previous years were also faired using this paste grade. Belzona 1593 was then applied as a two coat system. Frost blasting in between coats was utilised to mitigate any adverse environmental effects during the application. This was completed in accordance with Belzona System Leaflet TCC-05.
