Belzona protects new seawater filters for desalination

ID: 8484

Application: TCC-Tanks and Chemical Containment Areas

Application Date: October 2020

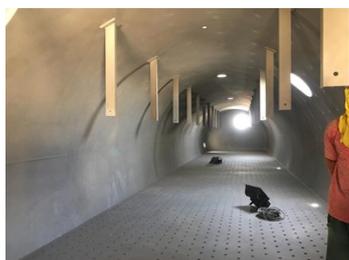
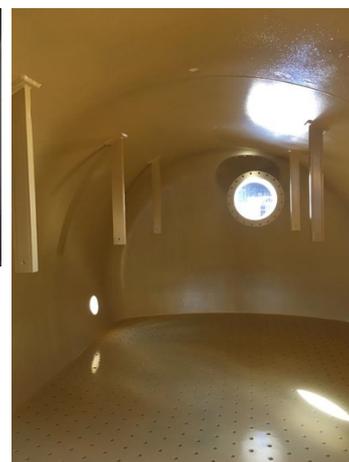
Photograph Descriptions

Due to the corrosive nature of seawater and erosion caused by suspended solids, a protective coating is necessary to mitigate potential damage to the steel shell and internal fixtures of the media filters.

- * 1. View of the filters from the outside ,
- * 2. Internal surface after surface preparation ,
- * 3. Internal surface after first coat ,
- * 4. Completed application ,

The coating was applied in accordance with a modified version of Belzona System Leaflet TCC-5, and in accordance with the Belzona 5821 IFU. The substrate was prepared using grit blasting to achieve the required surface cleanliness and profile. A two coat system of Belzona 5821 was then applied by airless spray.
